## **Modal Testing of a Repaired Building after 2010 Chile Earthquake**

Manuel Archila\*, Ruben Boroschek\*\*, Carlos E. Ventura\*, Sheri Molnar\*

*Keywords:* Ambient vibration, microtremor, modal testing, site period, earthquake damage

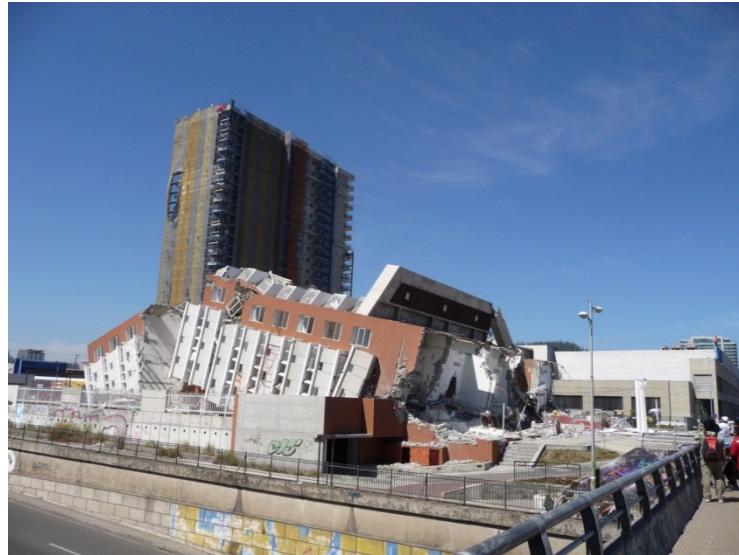
**Fig. 1** – Photo of a 15 storey reinforced concrete building in Concepcion city that collapsed during 2010 Chile earthquake.  
 (Photo courtesy of Perry Adebar)

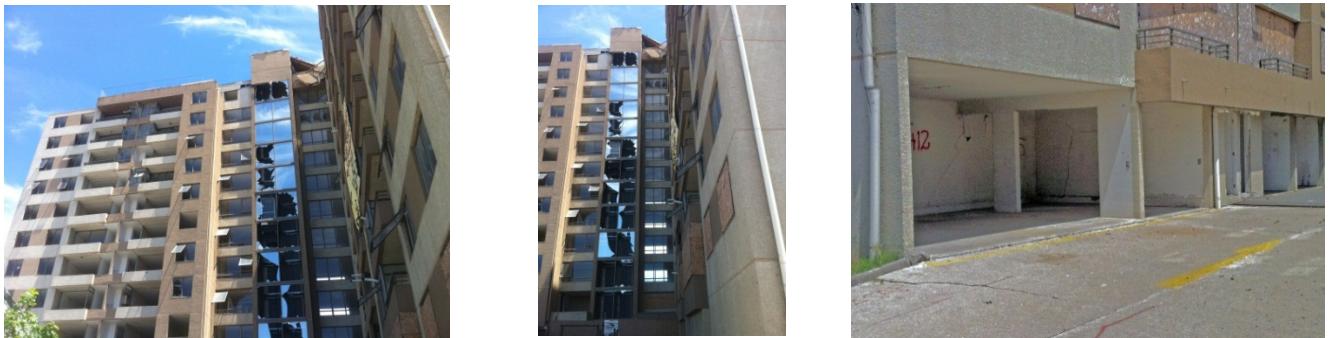
The pictures in Figure 4 show that the windows of the panoramic elevator suffered extensive damage. Partial collapse of the roof structure above the elevator was observed. The base of the walls above ground showed extensive cracking in horizontal and diagonal patterns. This building was considered inhabitable after the earthquake and has been slated for demolition. No access was allowed to this building; however the fundamental frequency of a shear wall building can be estimated using a rule of thumb described in equation 1.

where N is equal to the number of storey above ground level. Comparing the fundamental frequency of site 1 of 1.16Hz and the estimated fundamental frequency of this building, it is clear that seismic amplification of motion could take place due to resonance. This correlation confirms that ground conditions played an important role on the seismic damage caused by the earthquake which rendered the building inhabitable.

**Fig. 4** - Damage observed in 12-storey reinforced concrete building

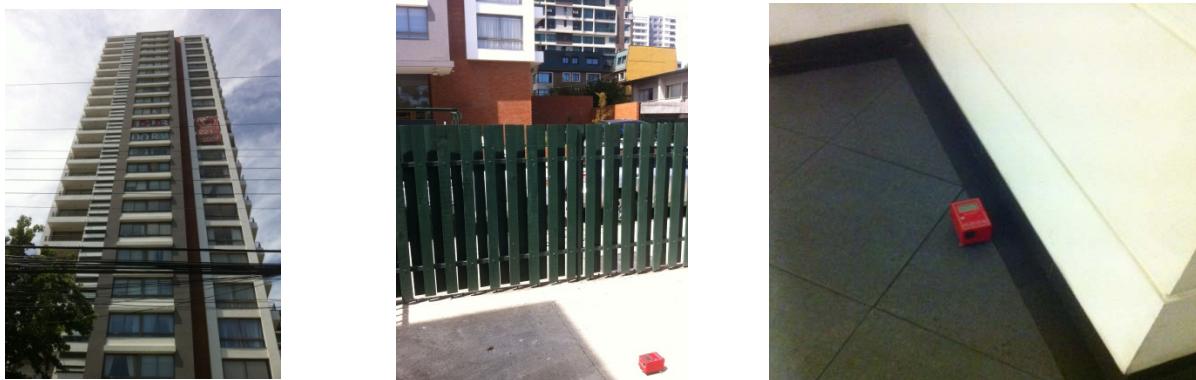
The building had been opened only for a month before the Chile earthquake of February 27, 2010. Residents evacuated the building as the shaking was very strong. No apparent damage was observable on this building from the outside, however posterior inspection of the structure showed that the walls at the base of the building were severely damaged. The structure was subsequently repaired.

**Fig. 5** – Elevation of 24 Storey Building and ambient vibration measurements

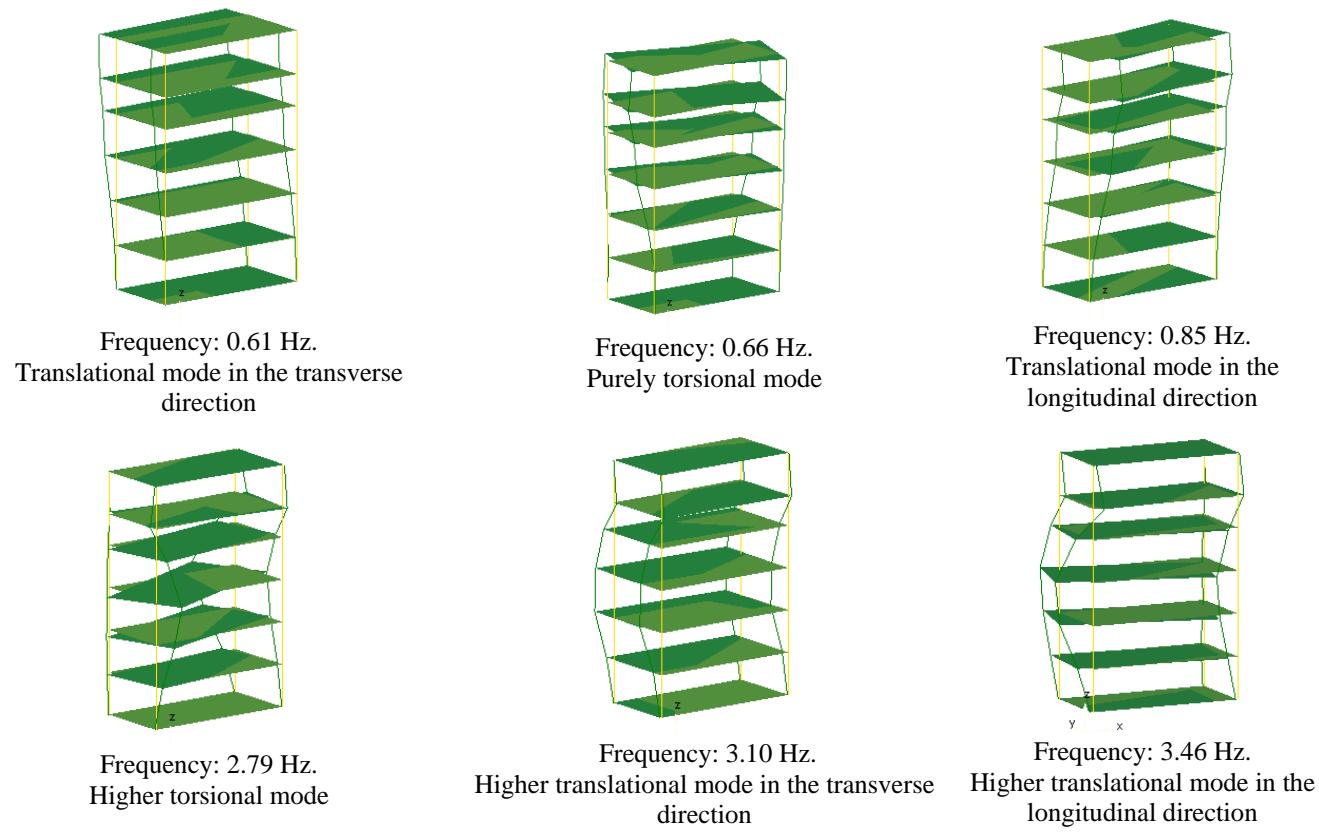
There is no information available regarding the condition of the building before the 2010 M<sub>W</sub> 8.8 earthquake. The building blueprints are not publicly available, and this prevents creation of any computer model to estimate the dynamic properties of the original building. Notwithstanding it is clear that the ambient vibrations measurements show that torsion is present in the dominant modes which might be a consequence of the earthquake damage.

**Fig. 8** - Modal shapes of repaired high-rise building

The mode shapes retrieved from the ambient vibration measurements of the 24 storey repaired building were strongly influenced by torsional vibration. There is no evidence available to confirm if this condition of torsional response corresponded to the original state of the building or was inflicted by the earthquake damage. As an engineering practice in active seismic regions ambient vibrations should be performed on structures to monitor mode shapes throughout their different states, undamaged, damaged and repaired, to assess severity of damage and confirm the effectiveness of repairs in restoring the structure to its original condition.
