## **Modal Testing of a Repaired Building after 2010 Chile Earthquake**

Manuel Archila\*, Ruben Boroschek\*\*, Carlos E. Ventura\*, Sheri Molnar\*

*Keywords:* Ambient vibration, microtremor, modal testing, site period, earthquake damage

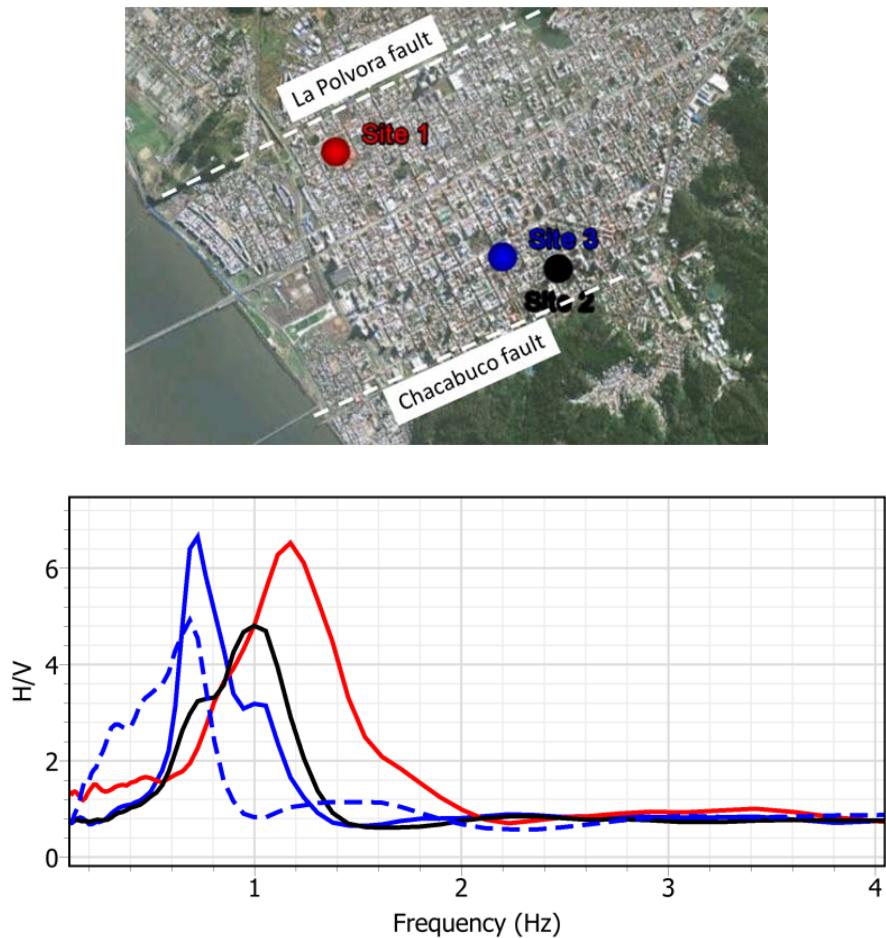
The results from free-field microtremor measurements at three sites are presented in this paper. Figure 3 shows site 1 is located south of the La Polvora fault, site 2 is located immediately north of the Chacabuco fault and site 3 is located closest to the centre of downtown Concepcion. Figure 3 also shows the average ambient-vibration H/V ratio results for these three sites; site 3 exhibits the lowest peak frequency (0.70 Hz) related to thick basin deposits, whereas sites 1 and 2 exhibit higher peak frequencies (1.16 and 0.97 Hz, respectively) towards the basin edges.

The 2010 M<sub>W</sub> 8.8 earthquake was recorded by the strong-motion instrument at site 3. The highest recorded peak acceleration here was 0.40g, which corresponds to a very strong shaking. The H/V ratios from the ambient vibration measurement (solid line) and the strong motion earthquake record (dashed line) are compared in Figure 3. The average ambient-vibration peak frequency is 0.72 Hz and the strong motion peak frequency is 0.70 Hz. Significant differences are observed in the shape of the H/V ratio curve.

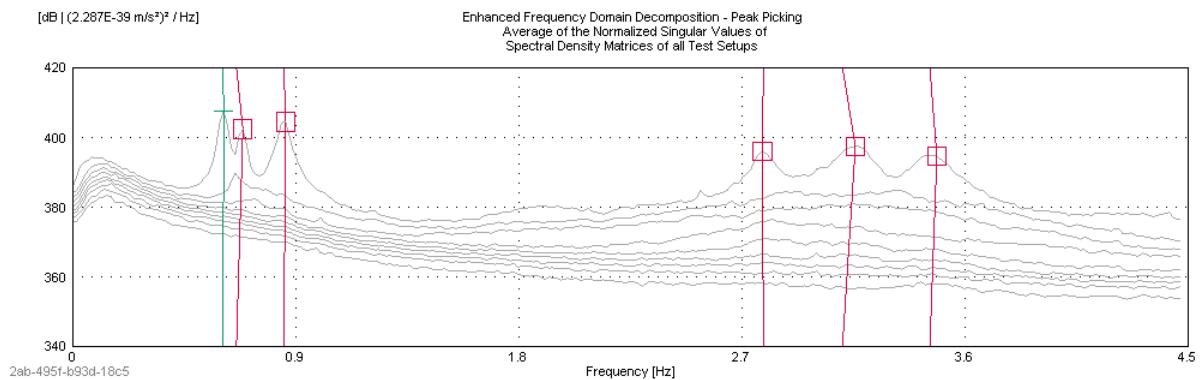
**Fig. 7** - Plot of Singular Value Decomposition of the average of all measurements

The model was developed using the seven different setups depicted in Figure 6. The peak picking method was used to select frequencies from the singular value decomposition plot shown in Figure 7. Six modal frequencies were identified. The summary of the modal properties obtained are listed in Table 1. The fundamental frequencies of the translational modes are 0.61Hz and 0.85Hz in the transverse and longitudinal directions, respectively. The damping ratios range between 1.5% and 2.0% which is expected at the ambient vibration level. The corresponding modal shapes are presented in Figure 8, only floors where measurements were taken are shown for clarity.

The fundamental frequency of the soil profile at site 2 where the building is located was determined to be 0.97 Hz (Fig. 2), and the dominant frequencies of vibration of the repaired building range between 0.61 Hz to 0.85 Hz. The frequencies are comparable and confirm that ground conditions also played an important role on seismic amplification of demands on the building that led to the severe earthquake damage observed.

There is no information available regarding the condition of the building before the 2010 M<sub>W</sub> 8.8 earthquake. The building blueprints are not publicly available, and this prevents creation of any computer model to estimate the dynamic properties of the original building. Notwithstanding it is clear that the ambient vibrations measurements show that torsion is present in the dominant modes which might be a consequence of the earthquake damage.
